Manhole Inspection Summary

Manhole # S25AA_016MH

Location Address: **1218 LANVALE ST**

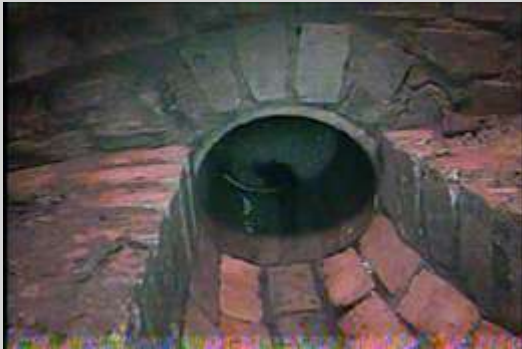
12 O'Clock Outflow

8 in. Circular Gravity Sewer
Pipe Out @ 12 O'Clock

Pipe Height: **8.4** (in.) Rod and Bar (Angled)
Pipe Material: **Clay** ☐ Pipe Lined
Invert Depth: **8.61** (ft.) Flow Characteristics: **Slow**
Deposits: ☒ None ☐ Mud ☐ Sludge ☐ Debris ☐ Grease
Silt Depth: (in.) Deposits Extent:
Infiltration: **None** Pipe Seal Cond: **Sound**

Drop: **None**

Connects To: **Manhole**

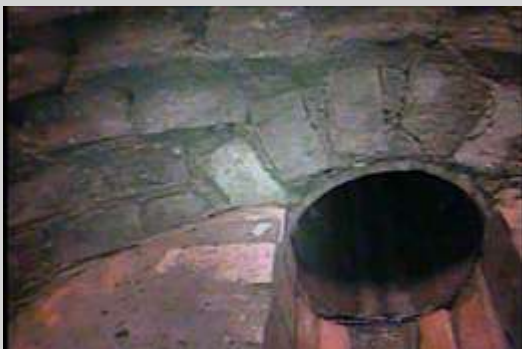
3 O'Clock Inflow

8 in. Circular Gravity Sewer
Pipe In @ 3 O'Clock

Pipe Height: **8.4** (in.) Rod and Bar (Angled)
Pipe Material: **Clay** ☐ Pipe Lined
Invert Depth: **8.10** (ft.) Flow Characteristics: **Slow**
Deposits: ☒ None ☐ Mud ☐ Sludge ☐ Debris ☐ Grease
Silt Depth: (in.) Deposits Extent:
Infiltration: **None** Pipe Seal Cond: **Sound**

Drop: **None**
